## City of Mansfield Stormwater Infrastructure

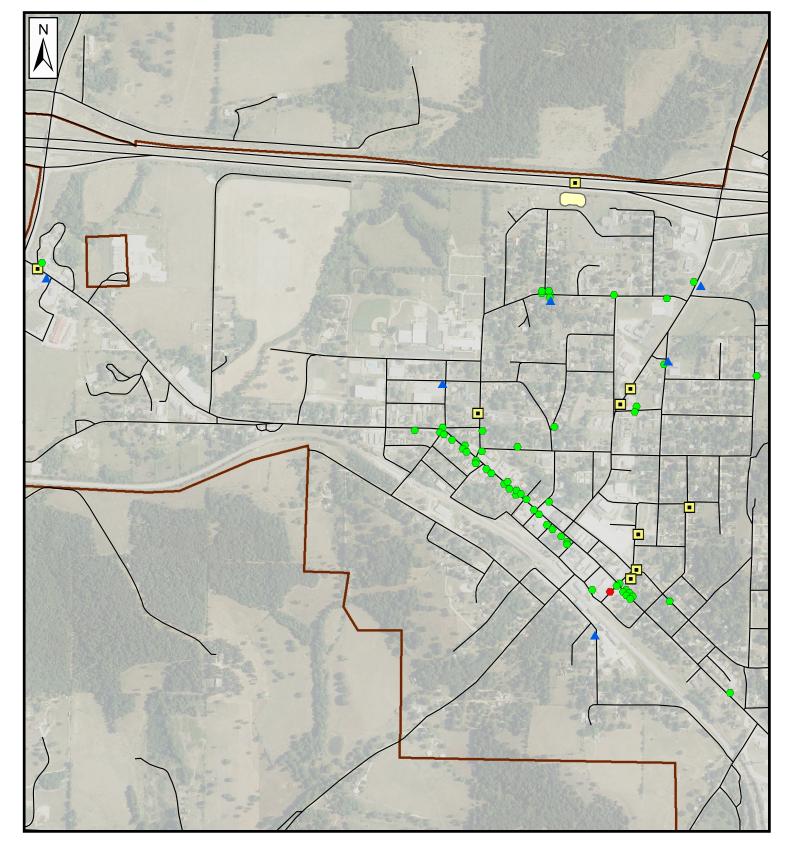
- Box Culvert
- Inlet, Poor Condition
